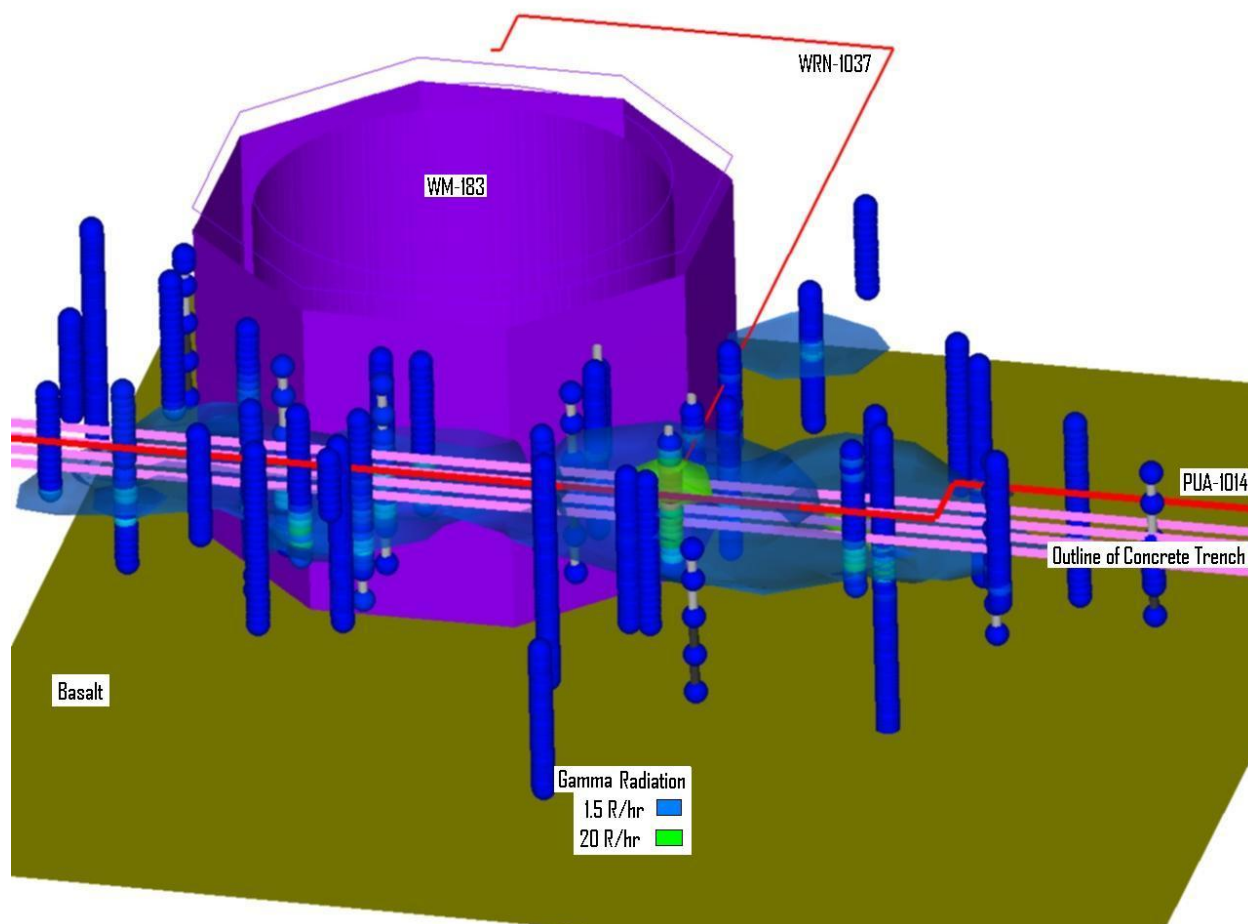
Figure 5-36. Volumetric prediction of gamma radiation extent within the CPP-31 leak zone. The top of the basalt is shown in dark green, the tank vault for WM-183 in purple, PUA-1037 and PUA-1014 lines in red, and a covered concrete trench outlined in pink. The observed gamma-logging locations are shown on the tubes. The plume represents 20 R/hr in green and 1.5 R/hr in blue.

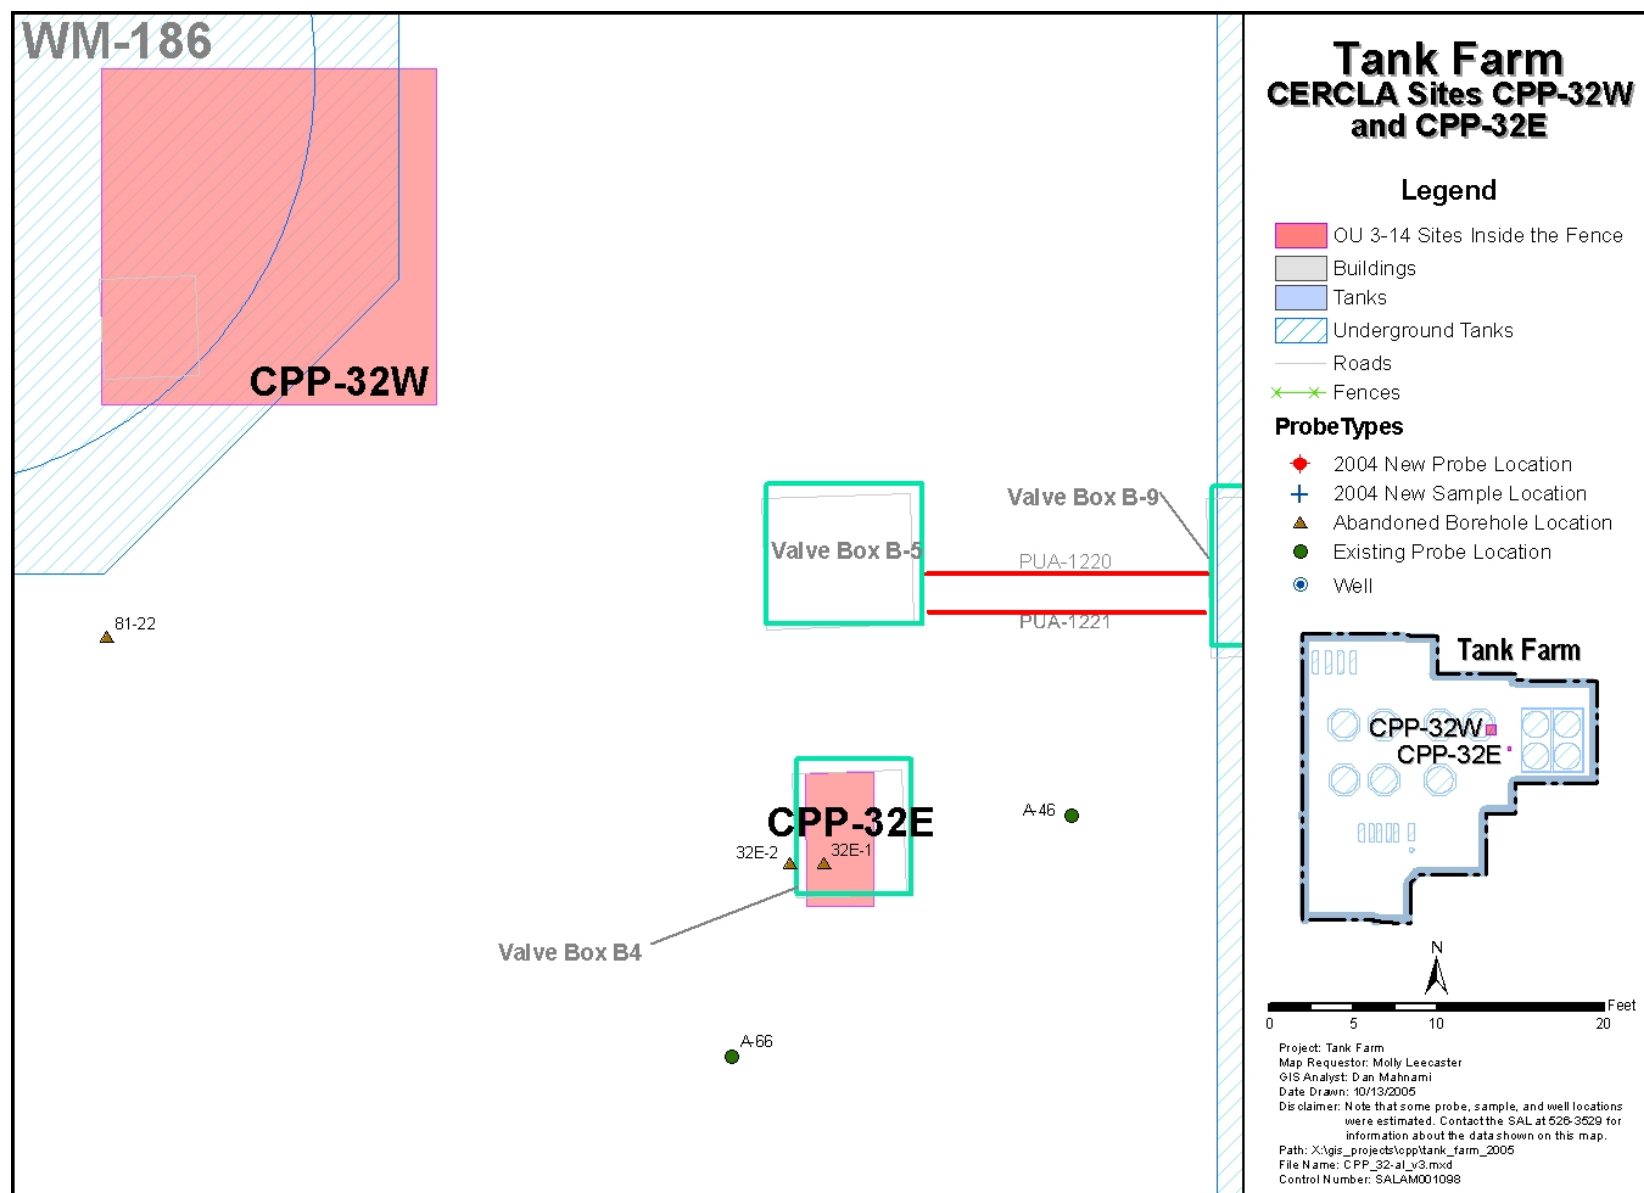
Figure 5-37. Detailed map of CPP-32E and CPP-32W.

Site CPP-32E is a small site located west of the four-pack tanks (WM-187 to WM-190), near the southwest corner of Site CPP-30 (see Figure 1-2, Figure 5-37). It is contaminated soil associated with sampling liquid in Valve Box B-4 sump.

DOE-ID (2004) postulated condensate from vapors exiting the inspection/sample port condensed and contaminated Site CPP-32E. However, the soil contamination levels (up to 2 R/hr) seem too high to have been caused by condensed vapor. For comparison, Site CPP-24 was likely contaminated by condensate from vaporized first-cycle raffinate (see previous CPP-24 description). The waste that evaporated, condensed, and contaminated the CPP-24 site was much higher in radionuclide activity (over 1,400 Ci/gal) due to much shorter fuel cooling times than the 1970s first-cycle waste (about 20 Ci/gal) that may have evaporated, condensed, and contaminated the ground near Valve Box B-4. The CPP-24 site was contaminated with an estimated 1 gal of liquid. The volume of condensate from the B-4

inspection/sample tube would have been relatively small, much less than a gallon. Having a larger waste volume with higher activity, the CPP-24 soil should have been more highly contaminated than the CPP-32E soil. However, the contaminated soil at CPP-24 had a much lower radiation reading (400 mR/hr) than the B-4 soil contamination (2 R/hr). This suggests another mechanism may have contaminated Site CPP-32E.

CPP-32W (see Figure 5-37, Figure 1-2) was likely contaminated by a release of approximately 1 gal of slightly contaminated water from a temporary, aboveground piping system that existed in the mid-1970s. The temporary piping system was used to transfer water from the vaults of the 300,000-gal tanks to the PEW evaporator feed collection system. The vault waste was primarily surface water that had leaked into the vault through joints in the vault roofs. The vault water was contaminated by small amounts of waste that drained into the vault from nearby valve boxes.

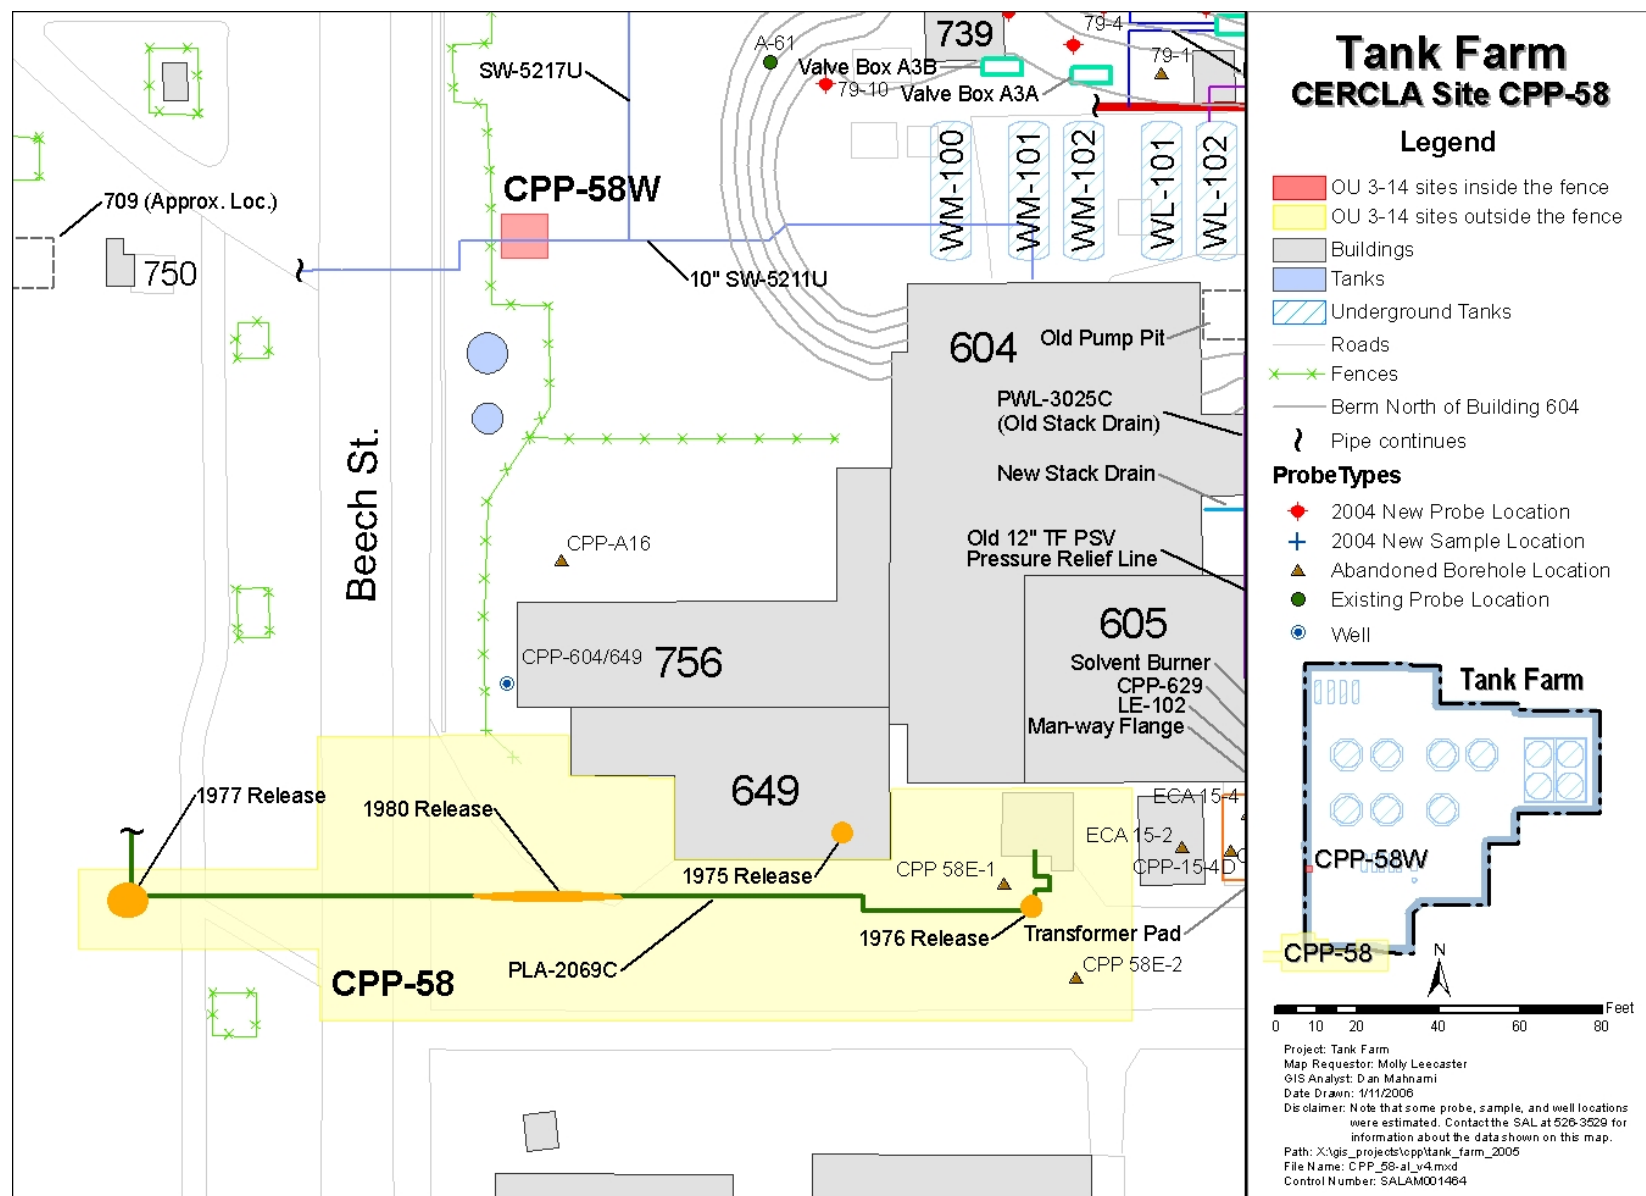
Figure 5-38. Detailed map of CPP-58.

In September 1976, a leak occurred (CPP-58E) when an elbow in the evaporator condensate line PLA-2069 failed. The failure point was as a result of piping changes made in 1975 to reroute a line when it failed the year before. The 1976 failure was attributed to thermal stress. The line was rerouted to relieve the stress, repaired, and returned to service.

Another leak from underground line PLA-2069 occurred in Site CPP-58 in October 1977, based upon information in Operations monthly reports. The leak was west of Beech Street at an elbow in Line PLW-2069 where the line turns from a westerly to a northerly direction (see Figure 5-38). At the time, Line PLA-2069 was used to transfer PEW evaporator condensate from CPP-604 to the service waste system. The leak was discovered when leaking liquid was observed seeping through the surface of the soil. An excavation revealed a failed elbow in Line PLA-2069. The line was repaired and the system was returned to service.
